1974, 45' **Downeast Lobster Yacht**

OUR FILE NUMBER	D14-11-2829
TYPE OF SURVEY	Condition & Valuation
DATE/TIME OF SURVEY	November 5, 2014 10:30am to 12:00pm
NAME OF VESSEL	GRACE
YEAR/MAKE/MODEL	1974 Downeast Lobster Yacht
PLACE OF SURVEY	Astor, Florida
HULL ID NO.	MDZH46007D47
OWNER'S NAME	Intn'l Seakeepers Society Inc.
OWNER'S ADDRESS	Miami, FL.
STATE VALIDATION NO.	N/A
HAILING PORT	Daytona Beach, Fl.
STATE REGISTRATION NO.	N/A
BUILDER	Dion Downeast Boats Nova Scotia
HULL MATERIAL	Cedar over Oak frames
HULL TYPE	Modified V
L.O.A.	45' 00"
BEAM/CLEARANCE	16' 00" 12'8"
DISPLACEMENT	33tons Gross 26tons Net
PROPULSION	(1) 1974 300HP Caterpillar
FUEL CAPACITY	600 US Gallons
INTENDED CRUISING AREA	Coastal/Inland Cruising
USCG DOC NO.	1238067
DOCUMENTED FOR	Pleasure

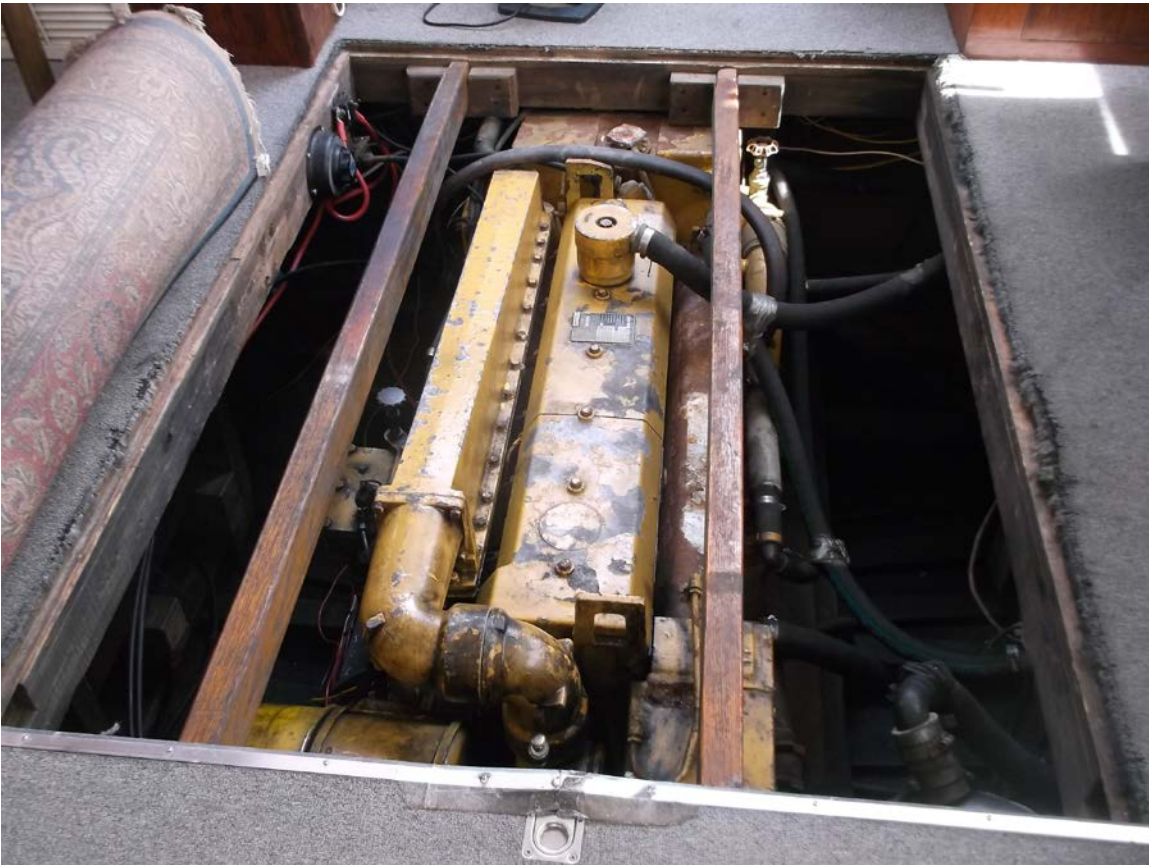
Photo No. 6 300hp Caterpillar Diesel.

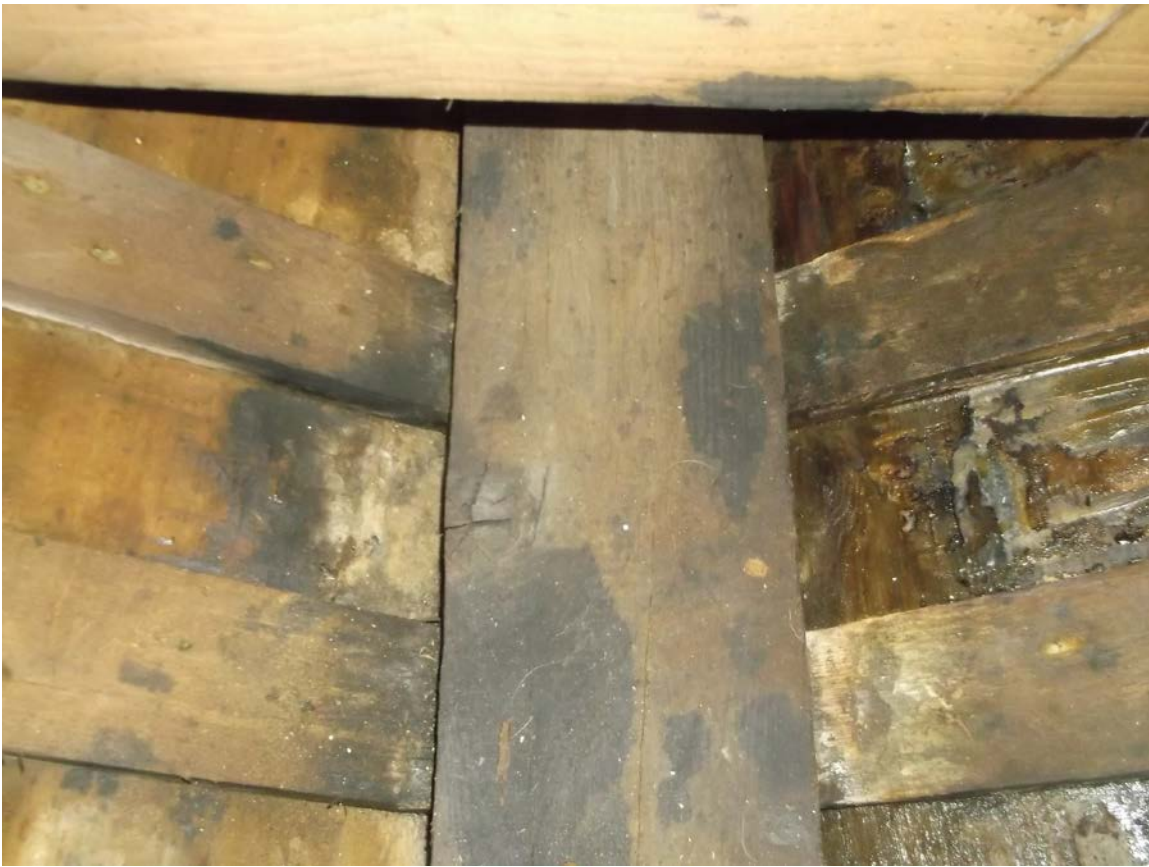
Photo No. 7 Forward bilge planking in good condition.

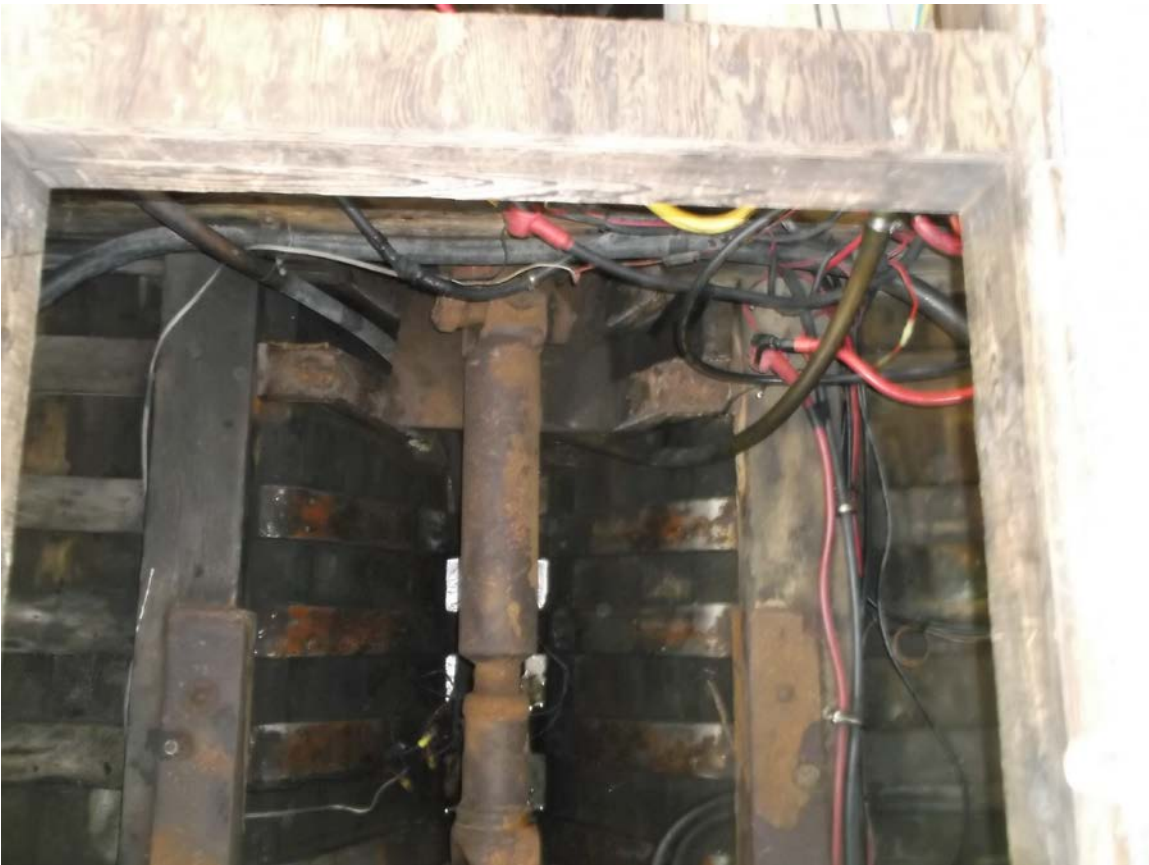
Hull Condition: Average, clean/dry bilges, minimal stringer deterioration.

Photo No. 8 Bilges amidships are practically dry and clean.

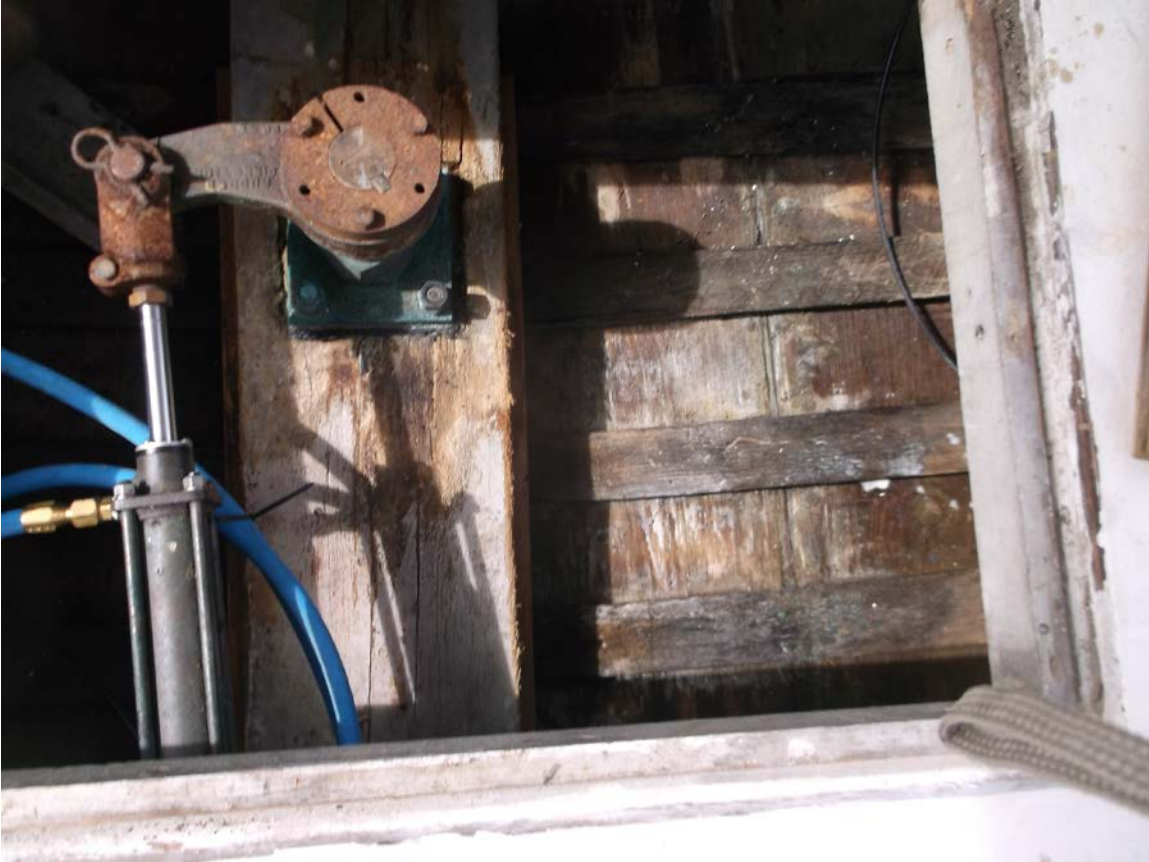
Photo No. 9 Aft bilge planking in good condition.

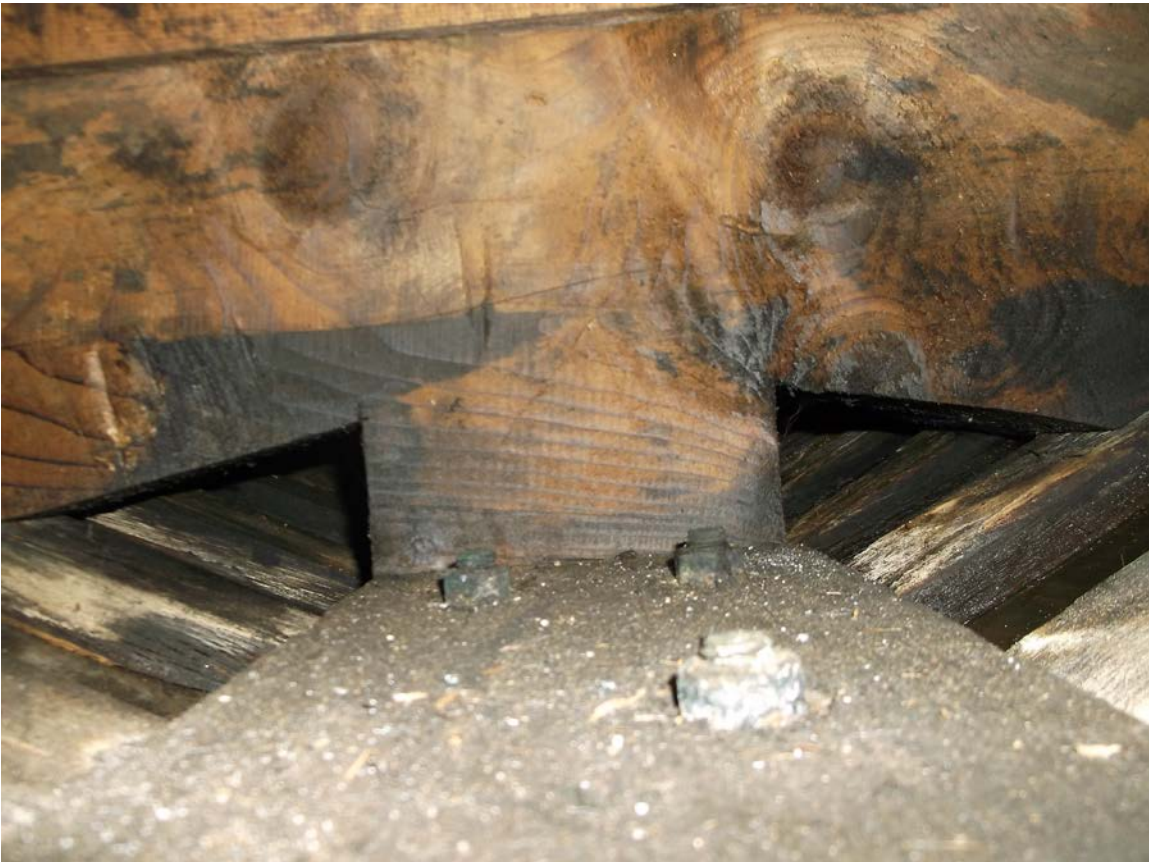
Photo No. 10 Very stout cross members and support stringers.
